NRL Memorandum Report 4123

Mechanical Properties of Wrought Iron from Hull Plate of USS MONITOR

C. D. BEACHEM, D. A. MEYN, AND R. A. BAYLES

November 20, 1979

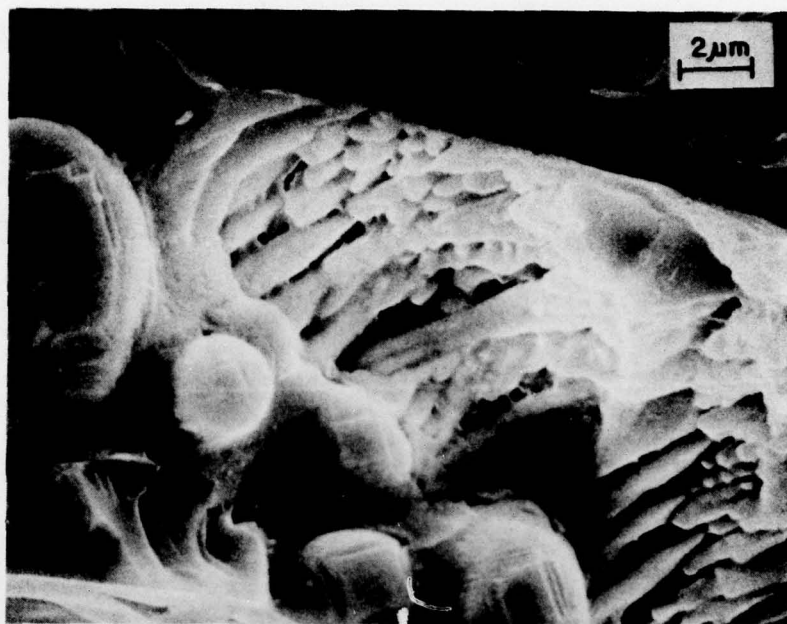
high resolution scanning electron microscope. Figure 6 shows a typical woody fracture surface and Figure 7 shows the flat delamination surface. At higher magnifications the fracture surface is composed of dimpled and flat surfaces indicating a combination of microvoid coalescence around inclusion particles, ductile tearing, and shear. The inclusion particles are silicates in the form of spheres and platelets. These silicates probably form much of the debris observed on the surface. Figures 8 and 9 are micrographs of typical fracture surfaces and Figure 10 shows an area of the delaminated surface. Two large silicate platelets lie on the delaminated fracture surface. At higher magnification, in Figure 11, is seen the two phase nature of these particular platelets. Note that the secondary crack passes straight through an embedded particle indicating good bonding at the interface between the particle and the surrounding silicate. Electron/x-ray spectrometry indicates that the small nodules are iron containing a small amount of titanium while the surrounding silicate is composed of iron, silicon, calcium, phosphorous, manganese, and small amounts of titanium, aluminum, and magnesium. The silicate particles observed on the typical fracture surfaces often show solidification structures in voids and dendritic structures as seen in Figures 12 and 13.

Fig. 12 — Faceted growth structures in siliceous void.
Specimen 0404B.

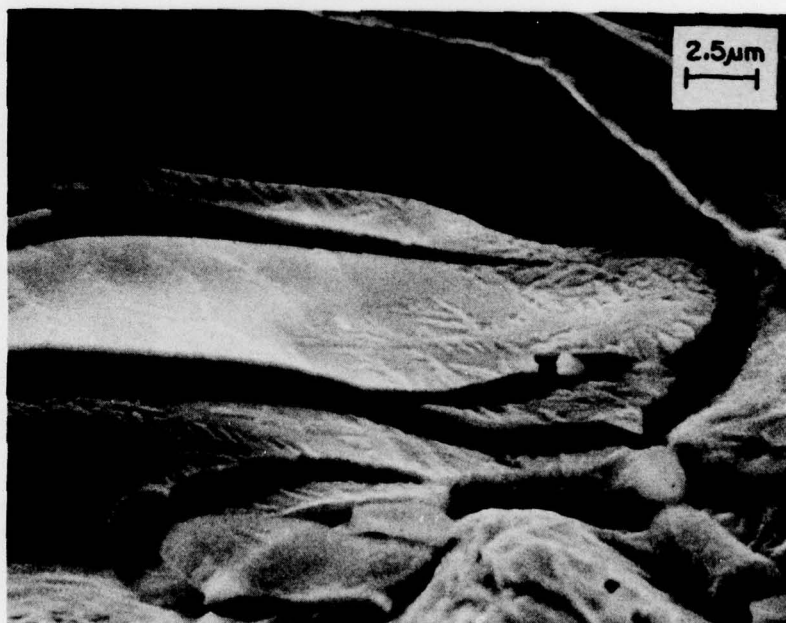
Fig. 13 — Dendritic second phase in silicate platelet.
Specimen 0405A.

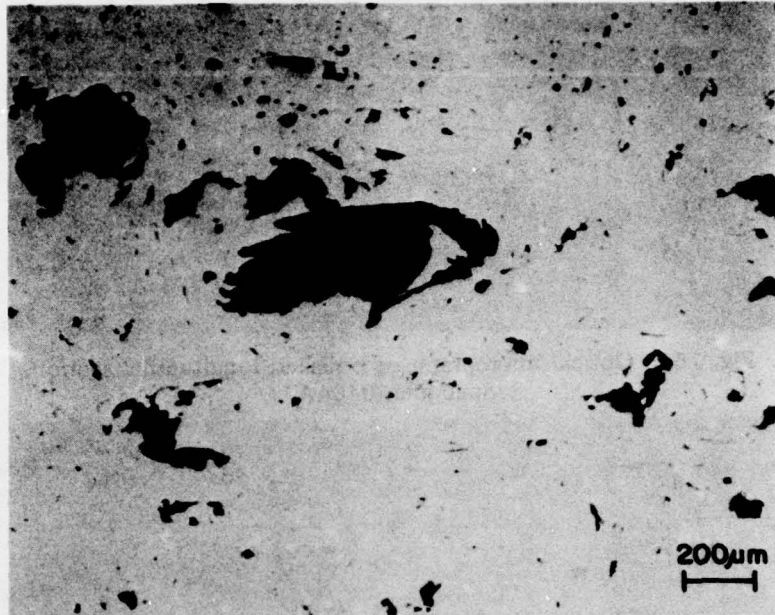
A typical magnified image from the face section obtained by an optical metallograph is shown in Figure 14. The inclusions have two types of composition as indicated by electron/x-ray spectrometry of this polished surface. Some smaller inclusions are composed of iron and silicon with small amounts of phosphorous and titanium. Some larger inclusions have a dendritic or spherical phase surrounded by another phase. This surrounding phase is composed of iron, silicon, calcium, phosphorous, sulfur, titanium, manganese, aluminum, and magnesium; while the inner phase is composed of the same elements but has less calcium, slightly less manganese, more sulfur, and somewhat more titanium.

**Fig. 14 — Optical micrograph of polished face section.
Specimen 0404A.**
